A DETERMINATION OF ELIGIBILITY
TO THE
NATIONAL REGISTER OF HISTORIC PLACES

FOR
SELECT HISTORIC PROPERTIES
ALONG THE SOURIS RIVER
IN NORTH DAKOTA

RENEWABLE TECHNOLOGIES, INC.

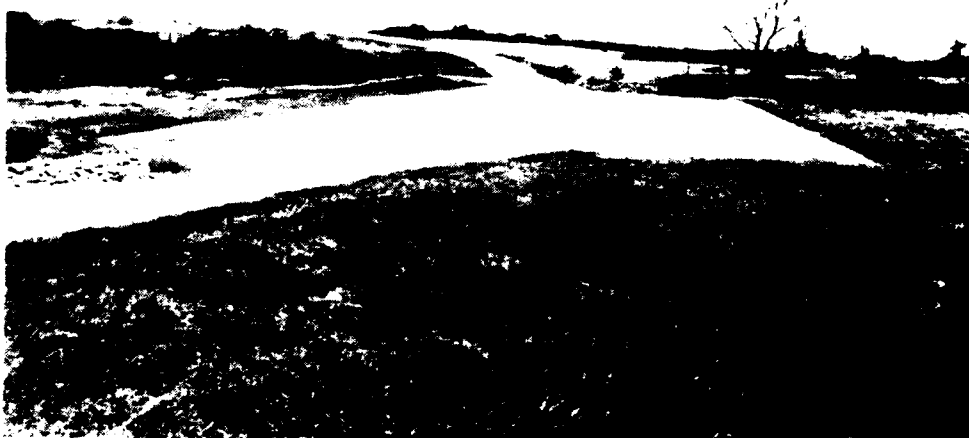
Figure 6. View of Dam 83 spillway showing the concrete weir, looking east.

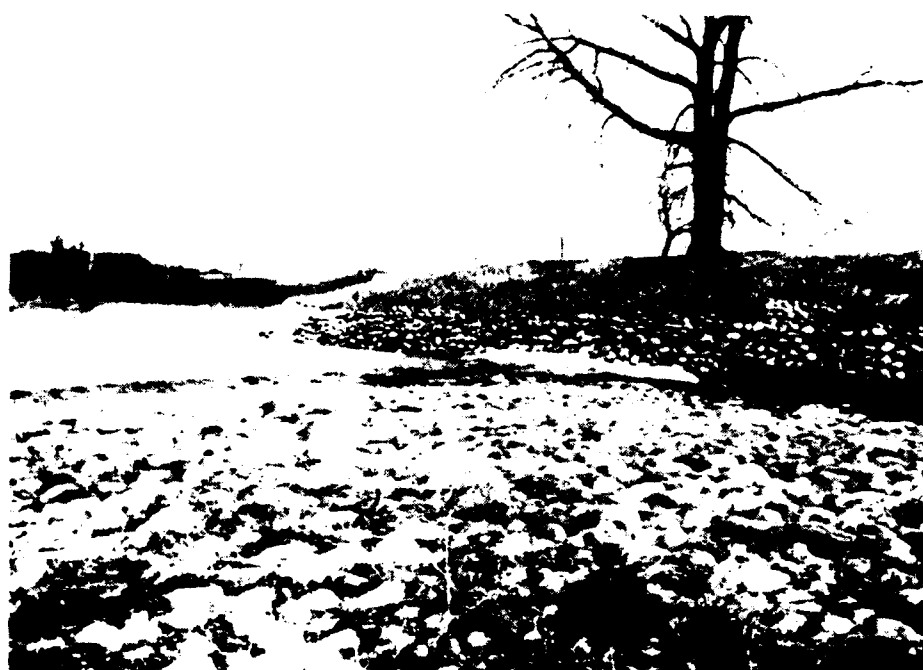
Figure 7. View of Dam 83 spillway showing concrete apron (background), stone paving, and stone masonry wing walls, looking northwest.

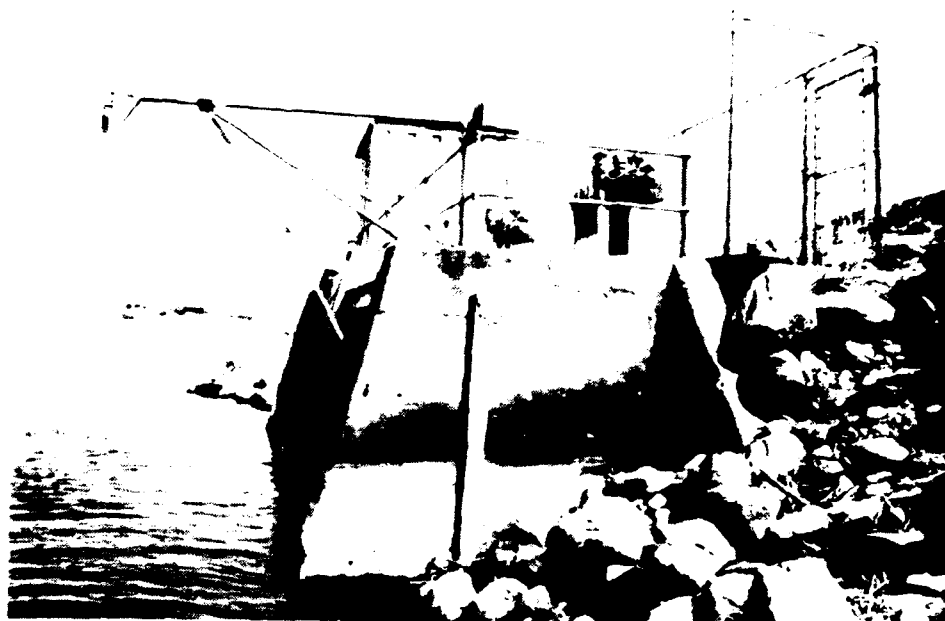
Figure 8. View of Dam 83 outlet works showing modern gate structure, looking east.

On the downstream side of the intake structure are two parallel 10-foot by 12-foot roller gates, each having a structural steel frame with a sheet metal skin on the upstream face. These gates were installed in 1981 and replaced the two original manually-controlled gates, which were each 12-foot by 10-foot, breast-wall, bronze-bushed, roller-bearing gates manufactured by the Hardesty Company.⁷ The present gates have slide gate operators on stands located on the deck of the intake structure. The operators for the gates are driven by electric motors and can be controlled manually on-site, or remotely from the maintenance shop near the east abutment.

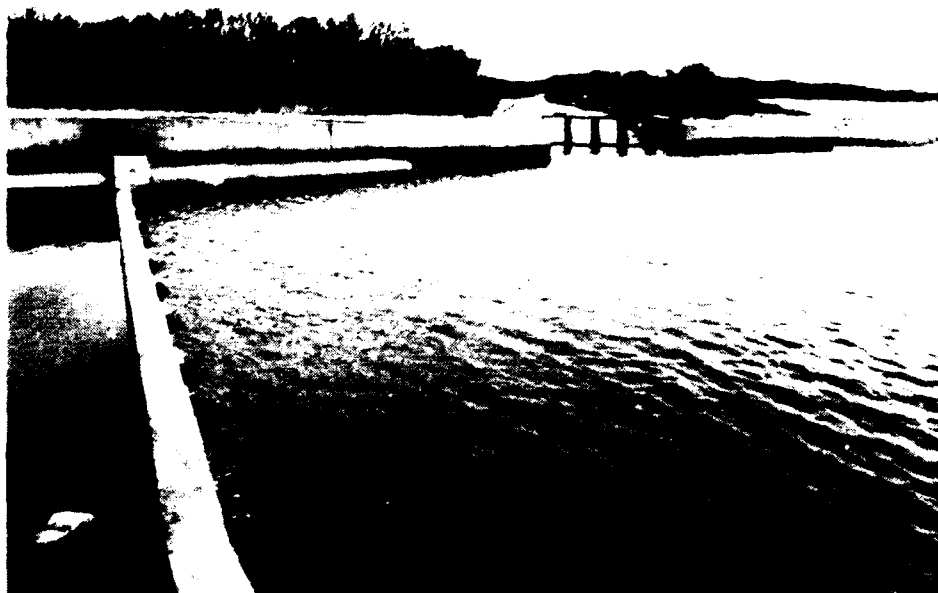
Figure 10. View of Dam 83 stilling basin showing baffle wall (left), and stop log outlet to the Souris River channel, looking east.

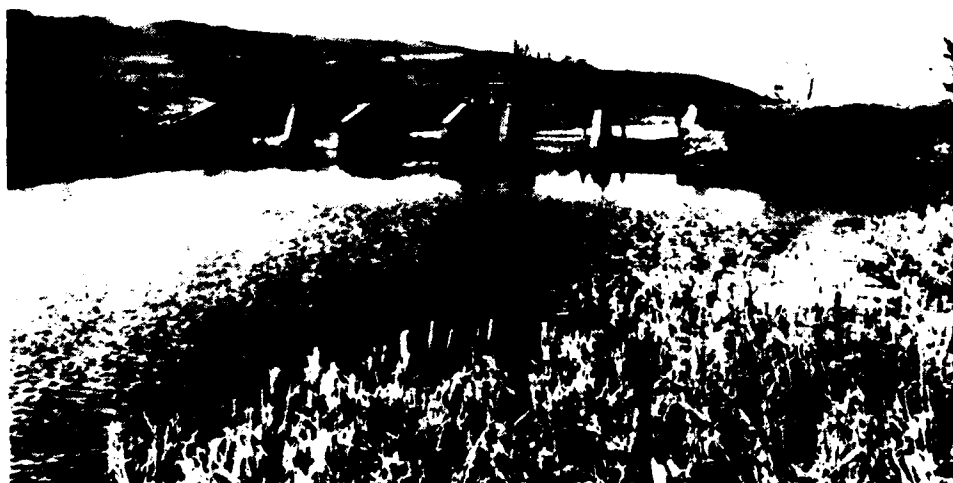
Figure 15. Downstream view of Dam 87 control structure, looking east.

The outlet works, located in a single bay near the middle of the concrete structure, consist of a radial gate measuring 16 feet by 8 feet with a top elevation of 1578.4 feet. The radial gate is located at the upstream side of the concrete structure. Just east of the radial gate is a 4-foot by 4-foot sluice gate. Both the radial gate and sluice gate are operated by manual hoists and the controls for the hoists are mounted on the walkway. The cast base for hoist controls reads, "Western Foundry Co., Portland, OR" and the wheel handle for the radial gate is embossed with the letters, "U.S.R.S.," which stand for United States Reclamation Service, the predecessor agency to the Bureau of Reclamation. Immediately downstream from the gates is a stilling basin which consists of a concrete apron and plunge pool.

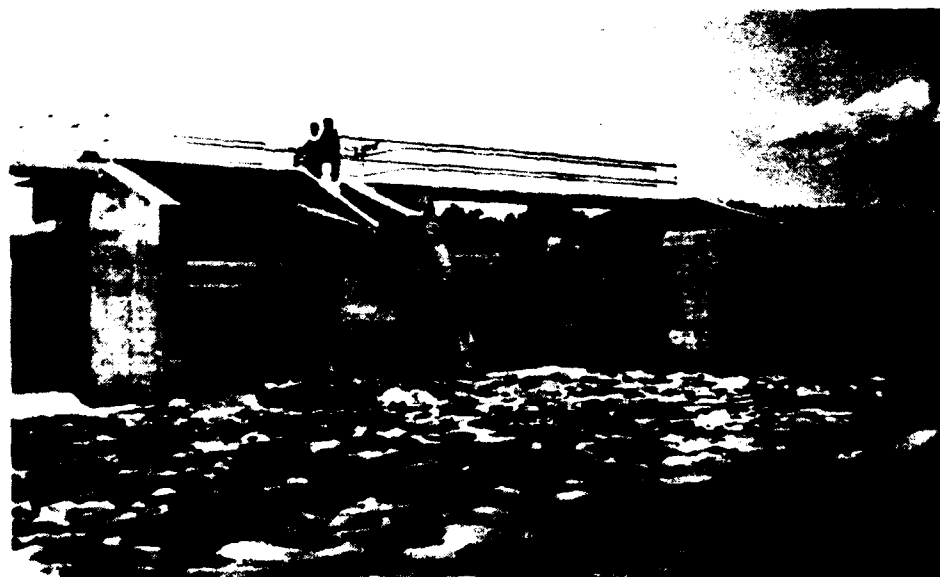
Figure 20. Historical view of Dam 96 showing lowering of the outlet works gate on May 26, 1936.

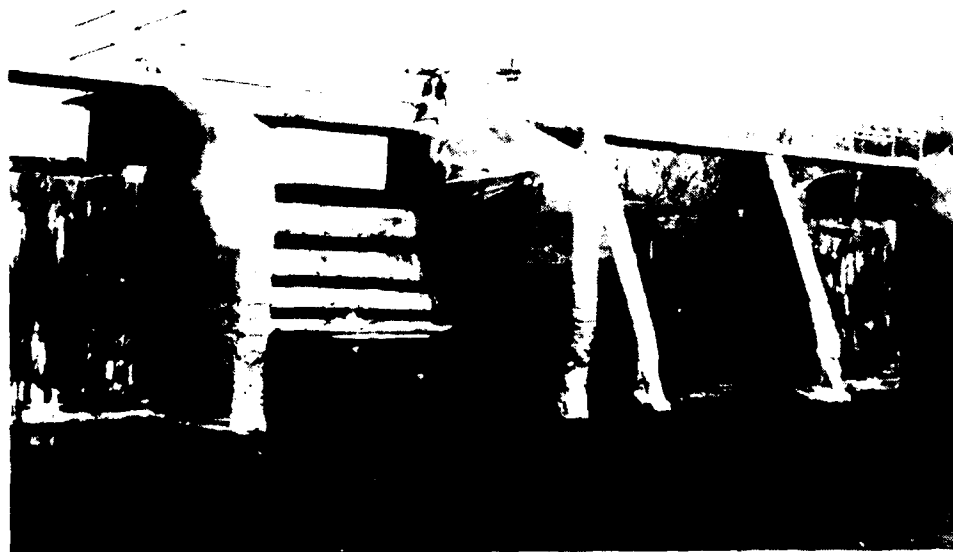
Figure 22. Downstream view of Dam 96 control structure showing detail of the radial gate at center, looking northeast.

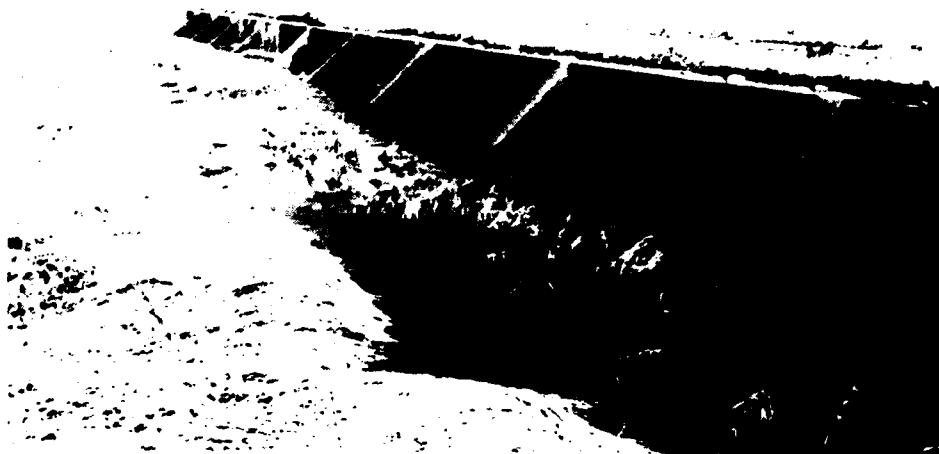
Figure 29. View of Dam 320 spillway showing concrete buttresses along the stone masonry weir wall, looking east.

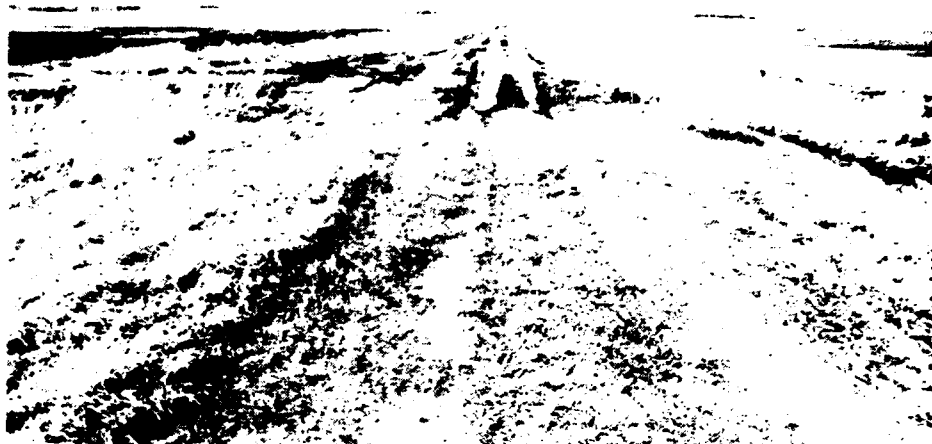
Figure 30. View of Dam 320 spillway as seen from the embankment, looking southwest.

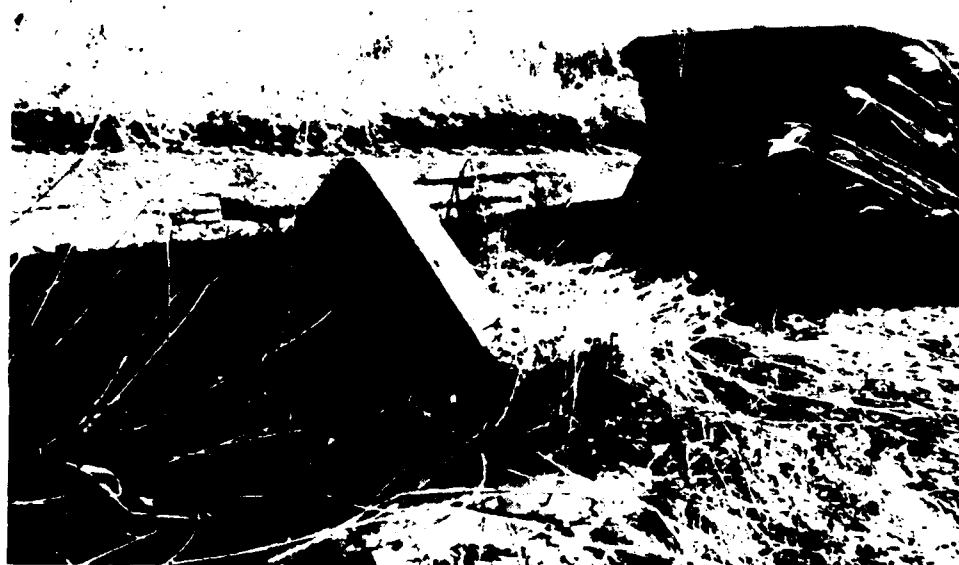
Figure 31. View of Dam 320 spillway weir wall showing concrete buttress and the southeast wing wall (concrete), looking south.

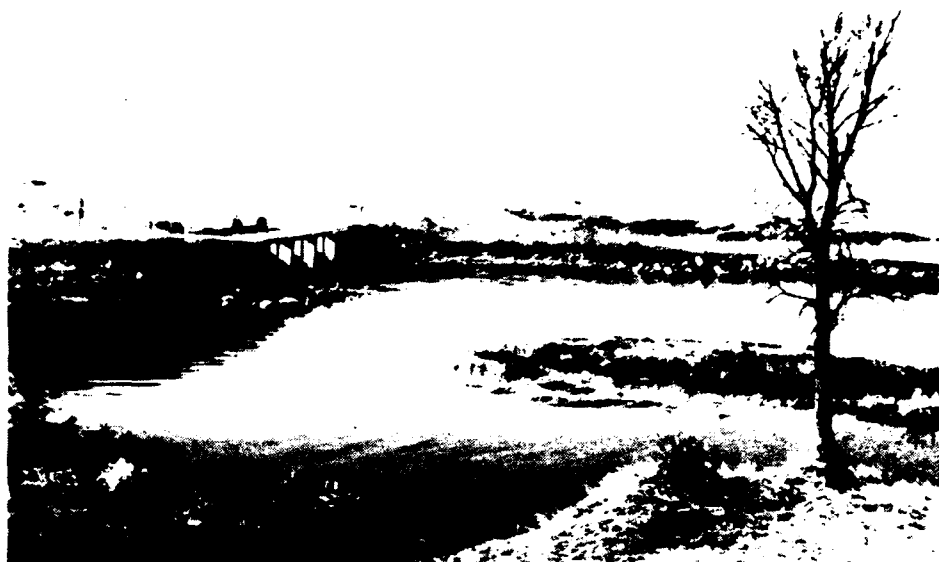
Figure 32. View of Dam 320 showing the outlet works (left center) and embankment, looking southwest.

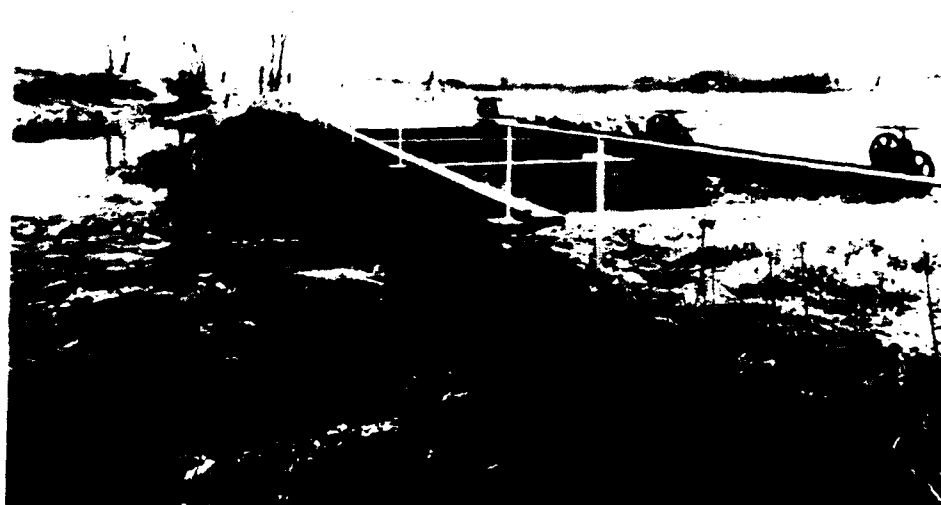
Figure 33. Downstream view of the Dam 320 outlet works (main structure), looking northeast.

The radial gates each consist of a corrugated steel face (16 feet wide by 10 feet high) with channel section supports and angle section radials. The outer face of each gate is set along the upstream side of the concrete

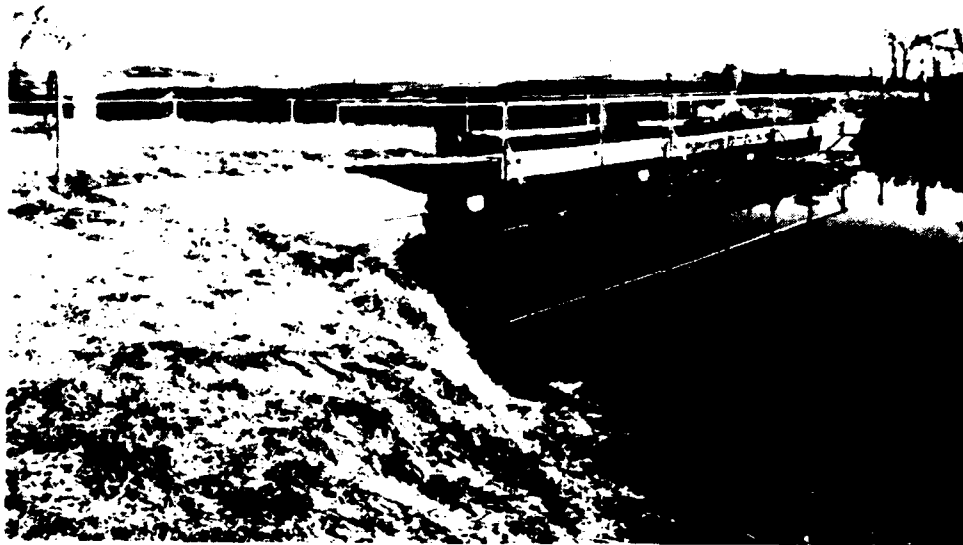
Figure 34. Upstream view of Dam 320 outlet works (main structure), looking north.

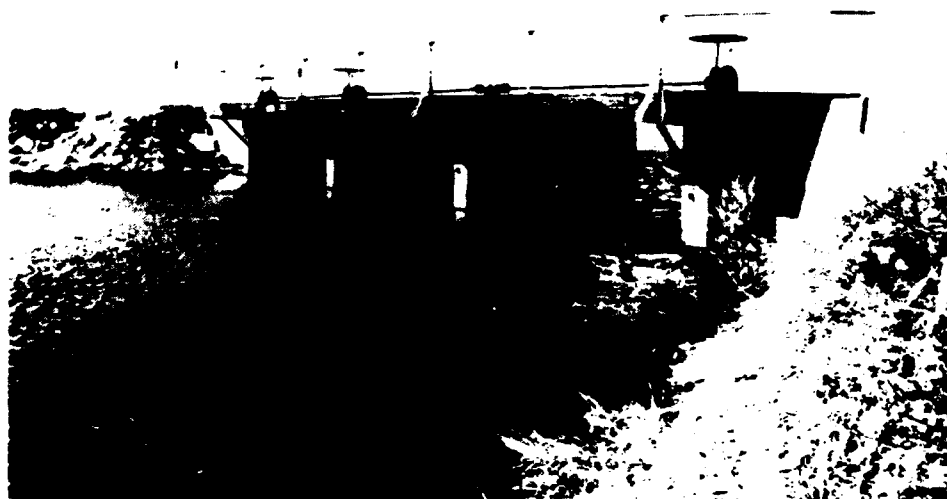
Figure 40. Upstream view of Dam 326 outlet works, looking east.

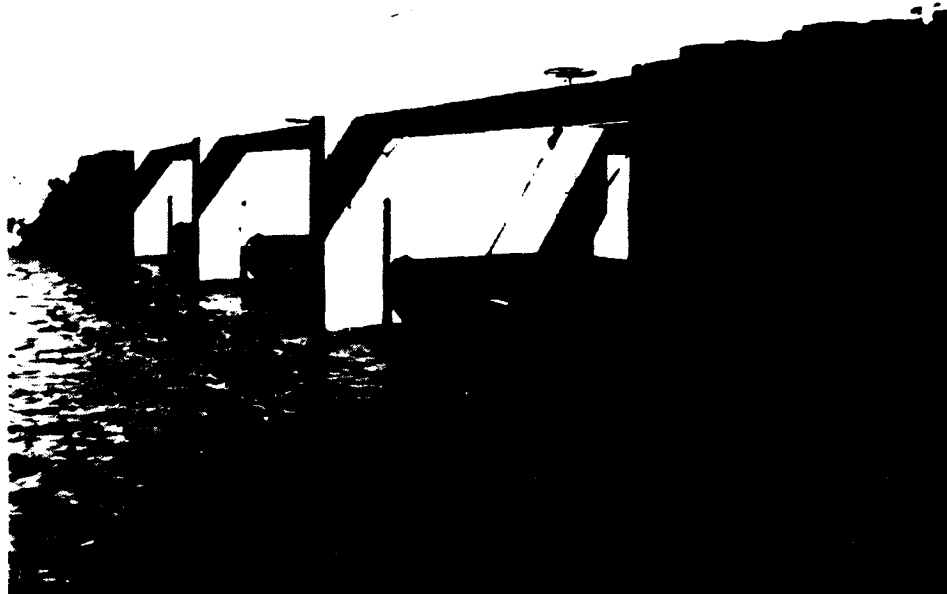
Figure 41. Downstream view of Dam 326 outlet works, looking east.

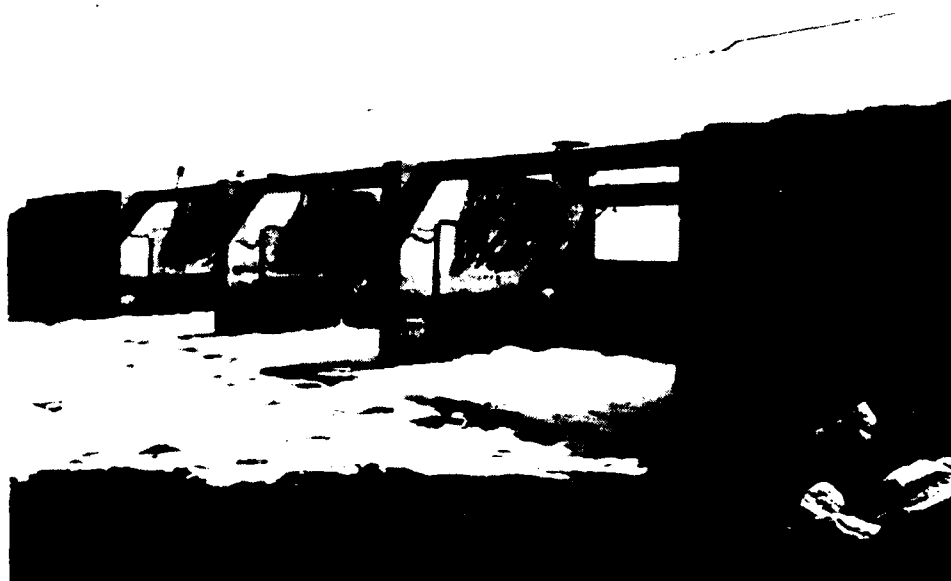
Figure 46. Downstream view of Dam 332 outlet works, looking southeast.

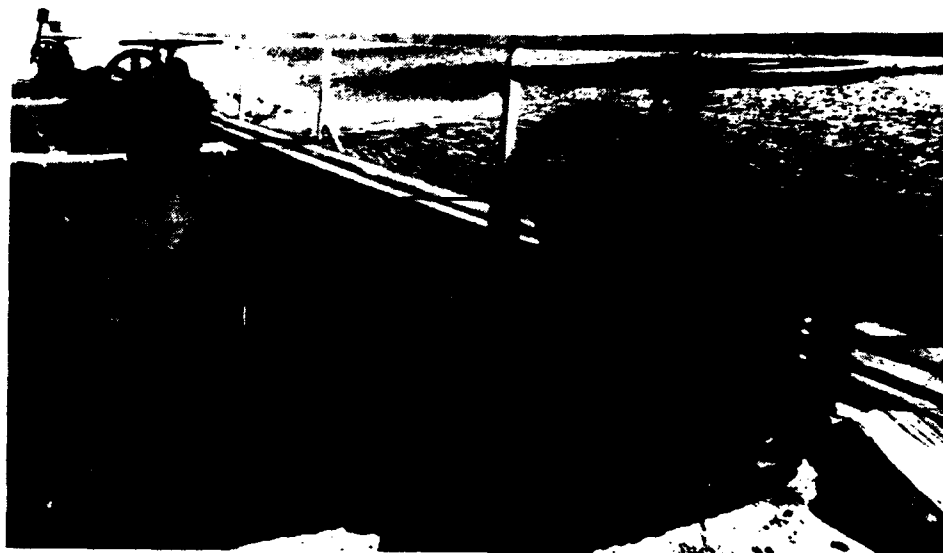
Figure 47. View of Dam 332 outlet works showing radial gate hoists, looking southeast.

The radial gates are operated by manual hoists. The hoist control for each gate is mounted on top of an adjacent concrete wall. Access to the hoist controls is provided by a cantilevered walkway along the structure's upstream edge. The walkway is secured to the structure by angle-section knee-braces and consists of a plank deck and an angle-section rail. Along its downstream side, the concrete structure also supports a concrete beam walkway that is protected by an angle-section rail. In 1949, the original height of the concrete structure was raised 3 feet by concrete caps that were added to the

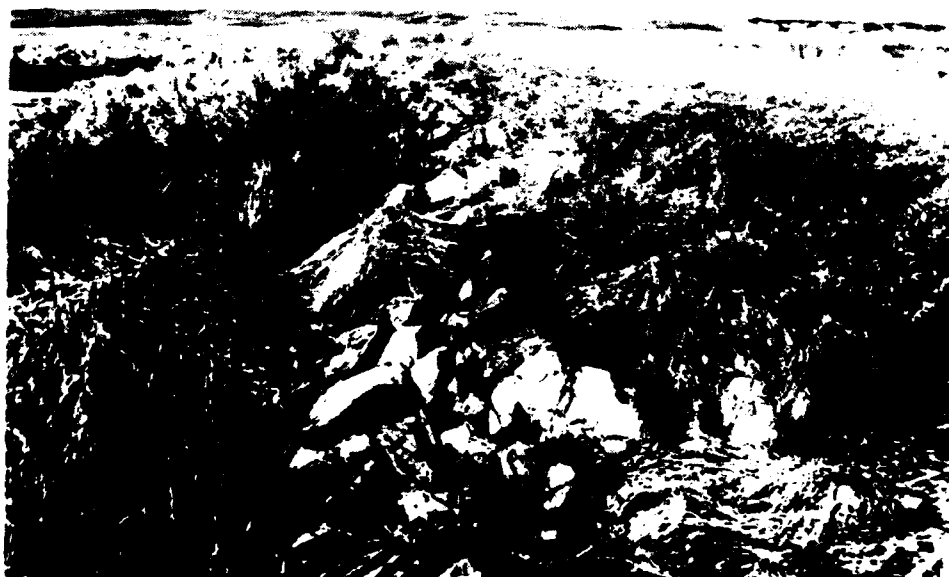
Figure 50. View of Dam 341 embankment, looking west.

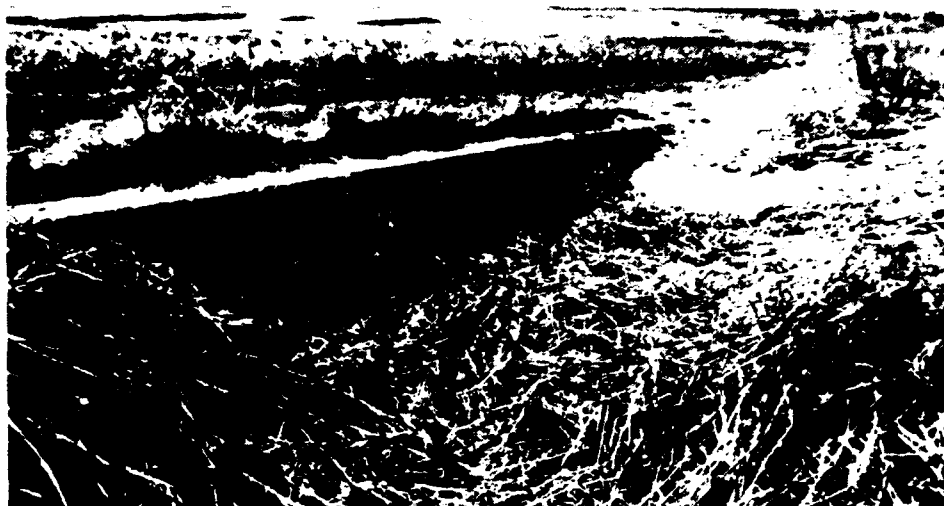
Figure 51. View of Dam 341 spillway showing concrete buttresses and cap added to the stone masonry weir wall.

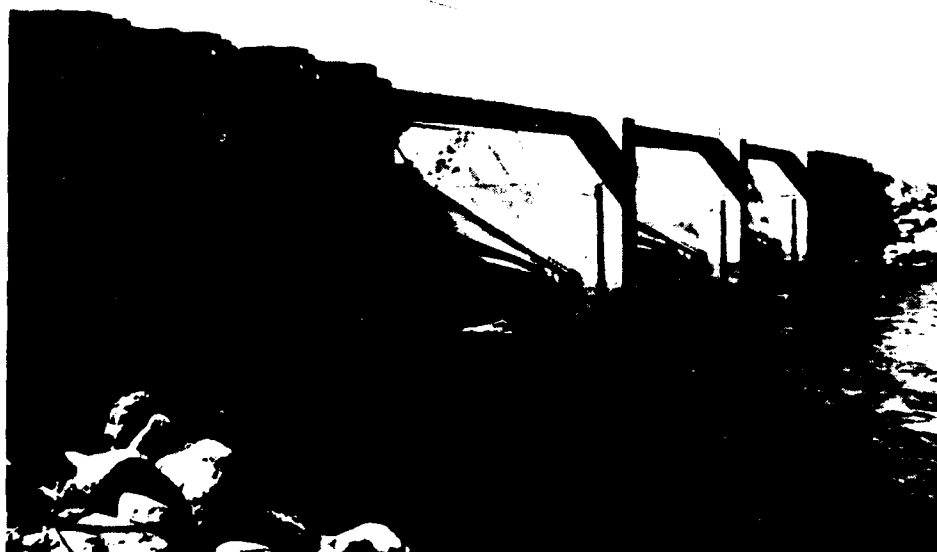
Figure 52. Downstream view of Dam 341 outlet works, looking southwest.

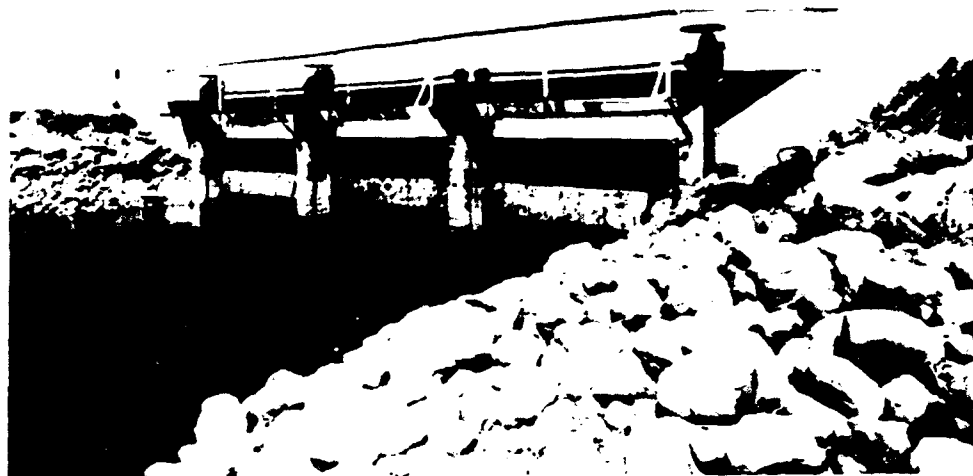
Figure 53. Upstream view of Dam 341 outlet works, looking northwest.

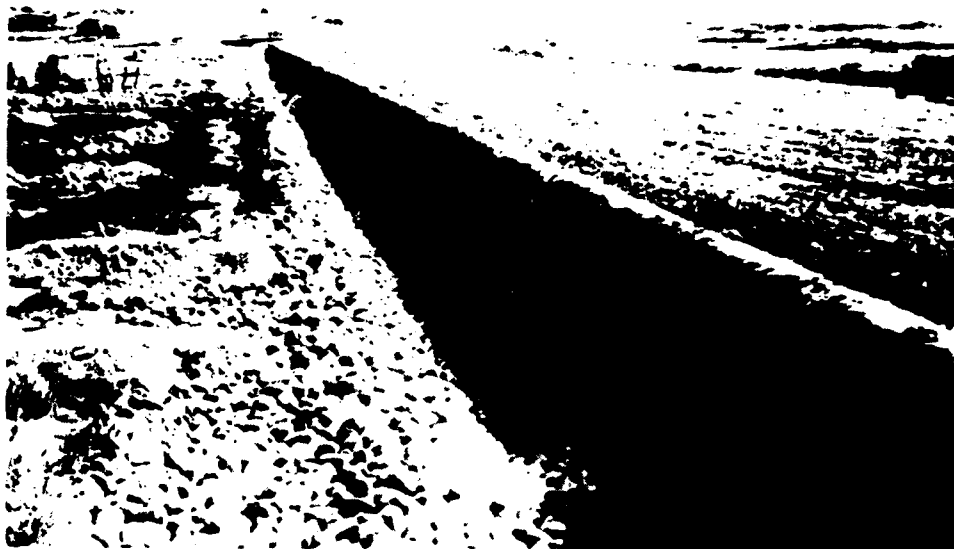
Figure 55. Historic view (1937) of Dam 357 spillway showing the stone masonry weir wall and apron.

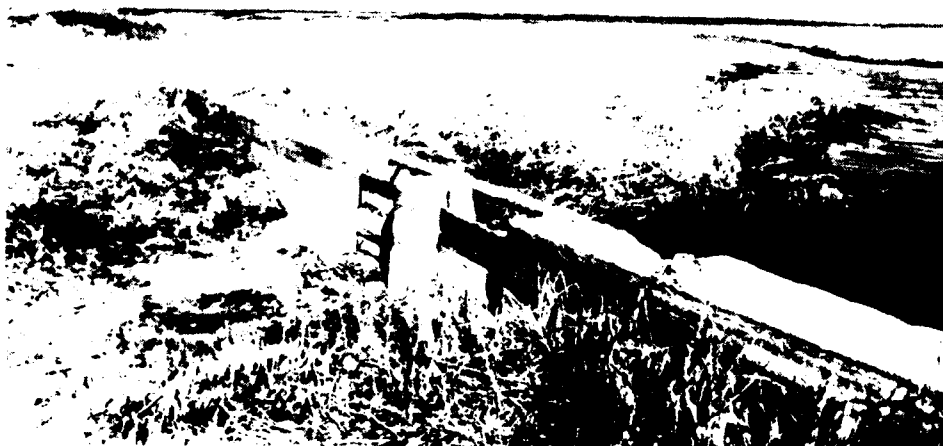
Figure 56. View of Dam 357 spillway showing stop log structure situated along the weir wall, looking northwest.

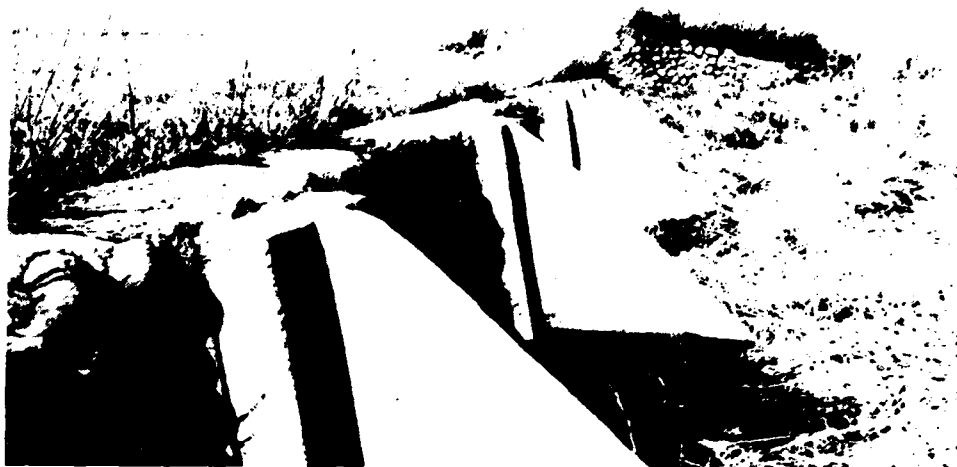
Figure 57. View of Dam 357 spillway showing concrete buttresses added to the stone masonry weir wall, and the east wing wall, looking west.

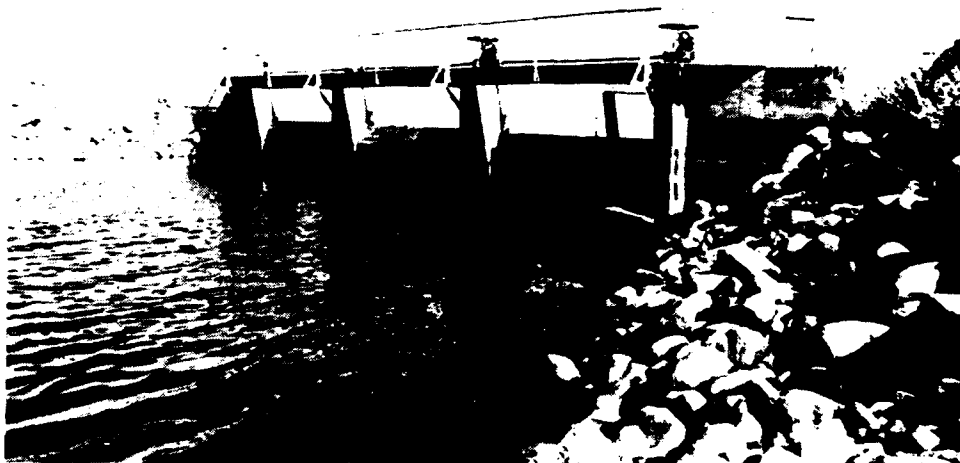
Figure 59. Upstream view of Dam 357 outlet works (main structure), looking northwest.

The main outlet works for the dam span the main river channel about 900 feet west-northwest of the right abutment (Figures 58, 59, and 60). It consists of a reinforced-concrete structure with three radial gates. The concrete structure is comprised of four, 18-foot long by 16-foot high walls (two end walls and two piers), which serve to support the radial gates. The downstream wing walls of the concrete structure are constructed of interlocking, corrugated sheet piling and upstream wing walls are concrete.

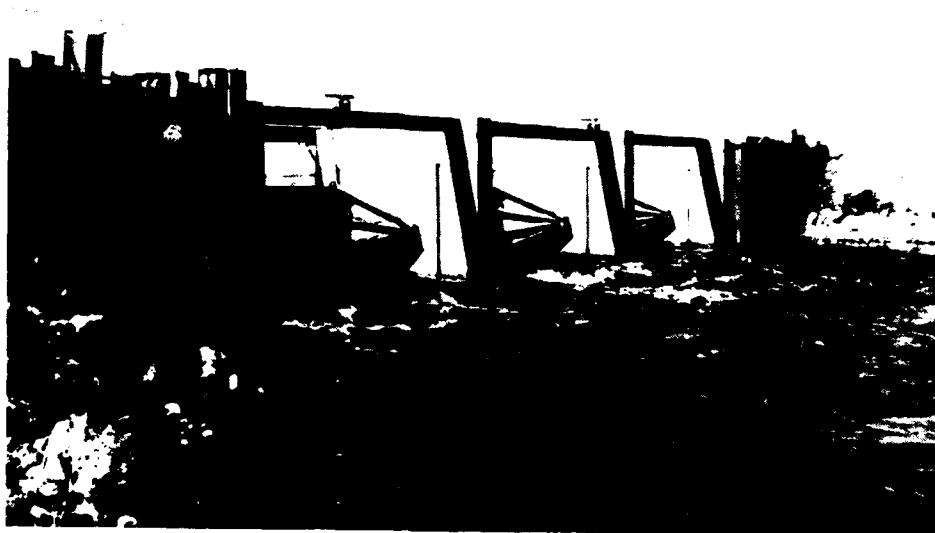
Figure 60. Downstream view of Dam 357 outlet works (main structure), looking southwest.

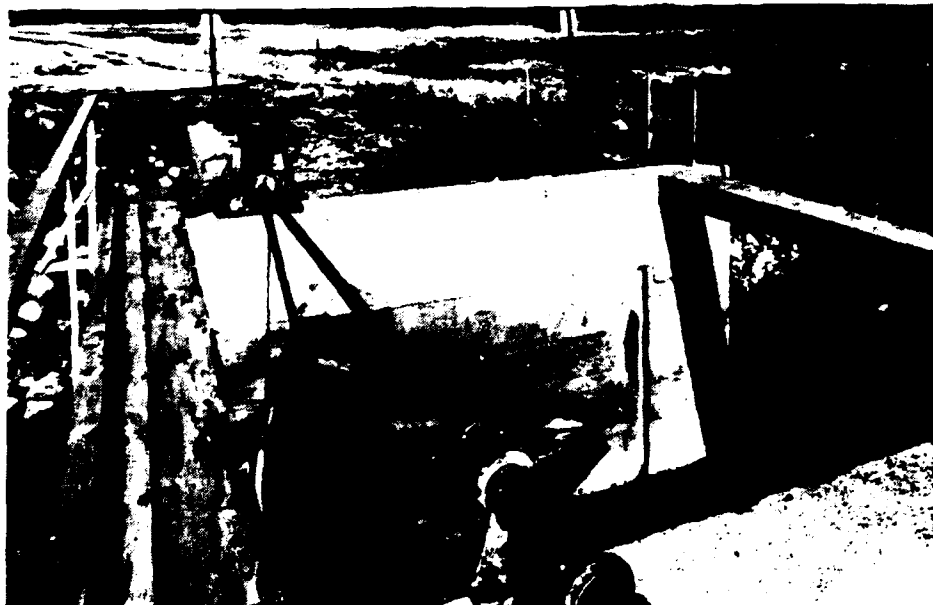
Figure 61. View of Dam 357 outlet works (main structure) showing detail of radial gate hoist, looking northwest.

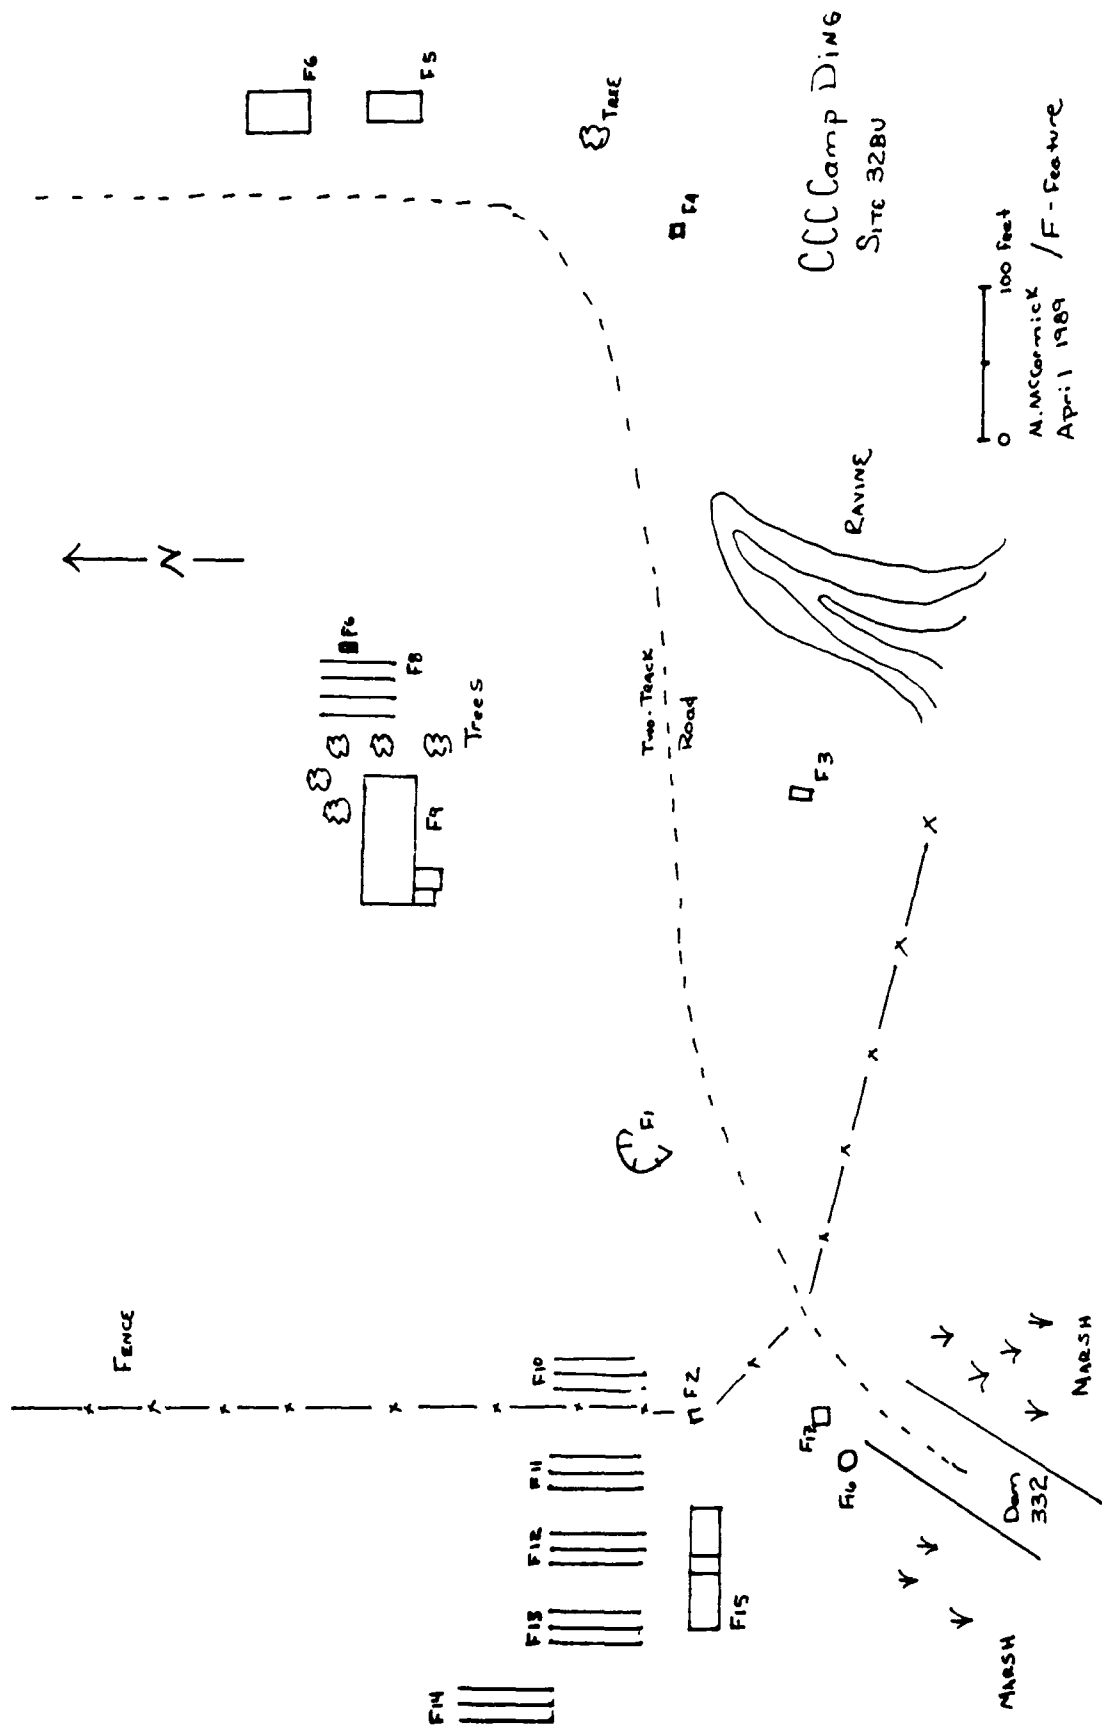
Figure 63. Sketch map of the site of CCC Camp Ding.

The remains of 17 buildings or structures (Features 1-17), exist at the site of Camp Ding, consisting primarily of the remnants of concrete foundations (Figures 63 and 64). Following is a descriptive list of the 17 site features. The historic function for a few of the features is based on interpretations made from CCC records listing all of the camp facilities by function and overall dimensions.

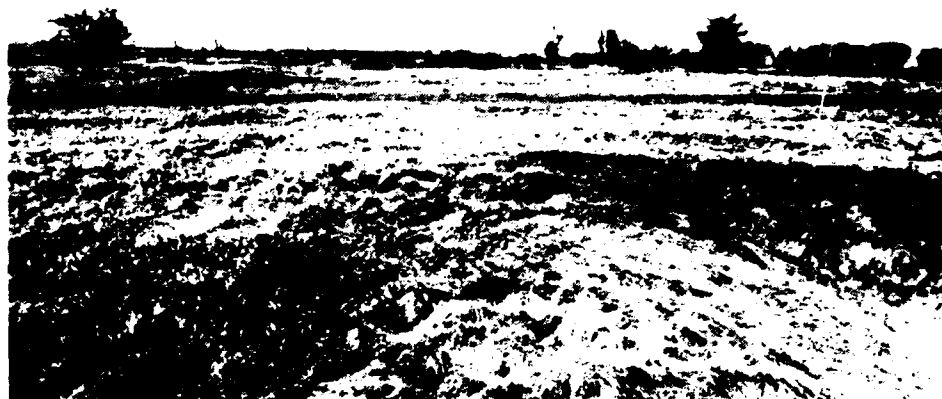
Figure 64. General overview of the CCC Camp Ding from the south end of the site looking north showing Feature 1: concrete foundation and mound at left center and Feature 15: concrete foundation slab and footings (bathhouse and latrine remains ?) at tree at far left center.

Feature 1: consists of a semi-circular mound (18 feet east/west by 35 feet north/south) with remnants of a low concrete foundation wall along its east edge.

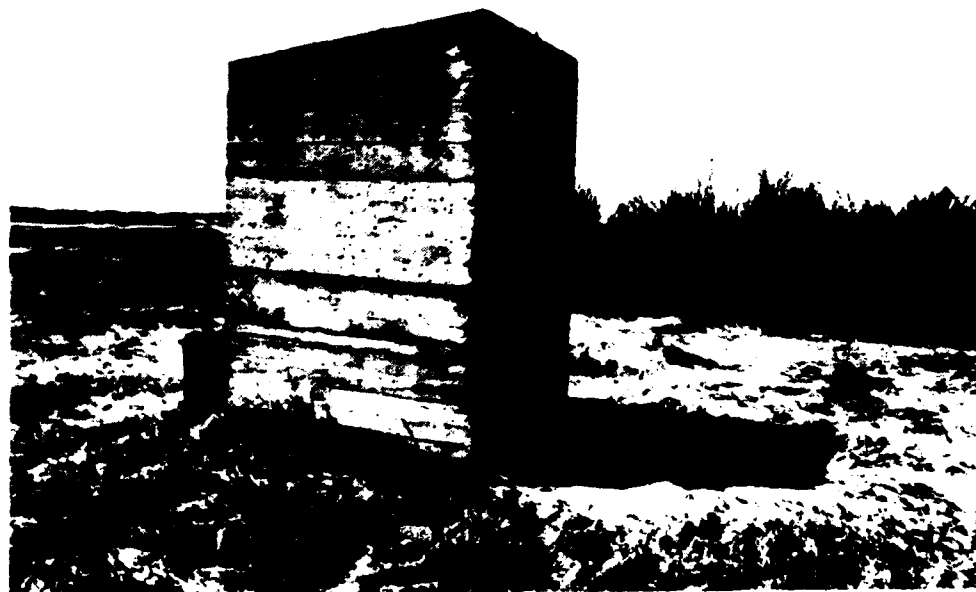
Figure 65. Feature 4: standing concrete structure (partial building remains), view to the southwest showing north and east walls.

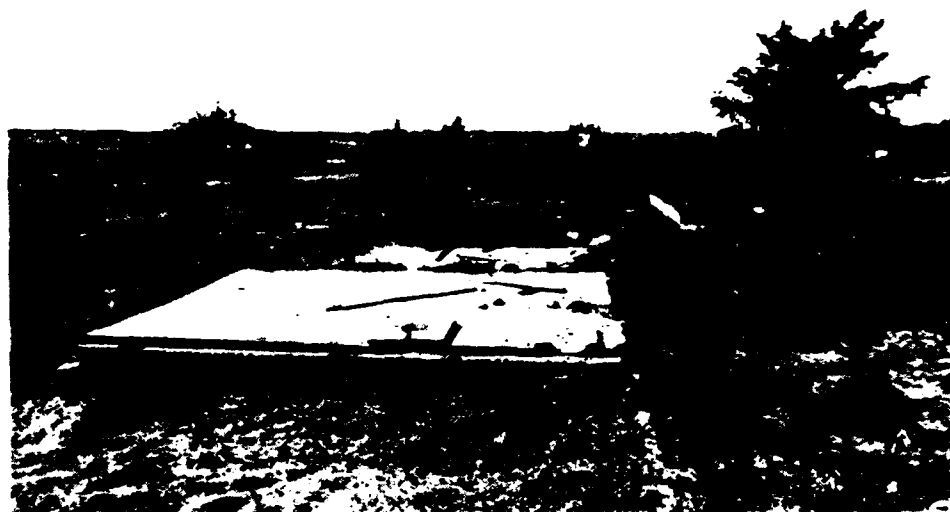
Figure 66. Feature 9: concrete foundation slabs and low walls, view to the west.

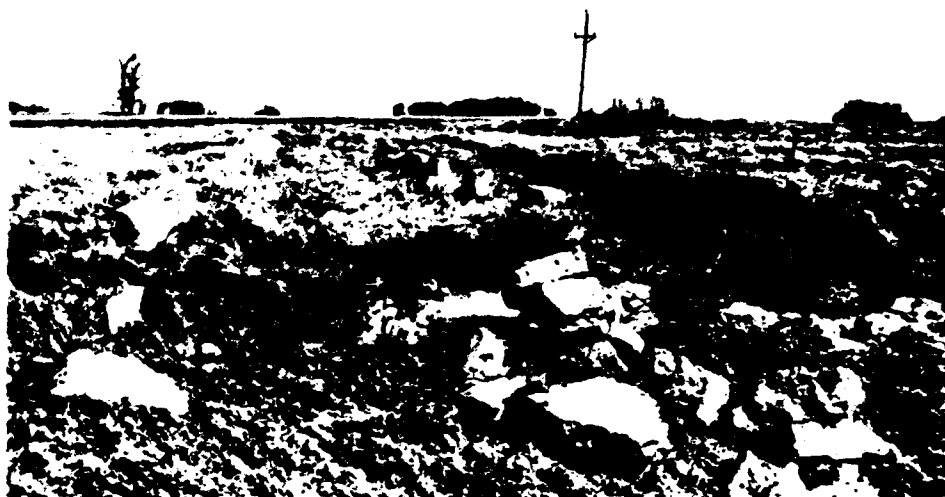
Figure 67. Feature 14: concrete foundation walls (bunkhouse remains?), view to the north.

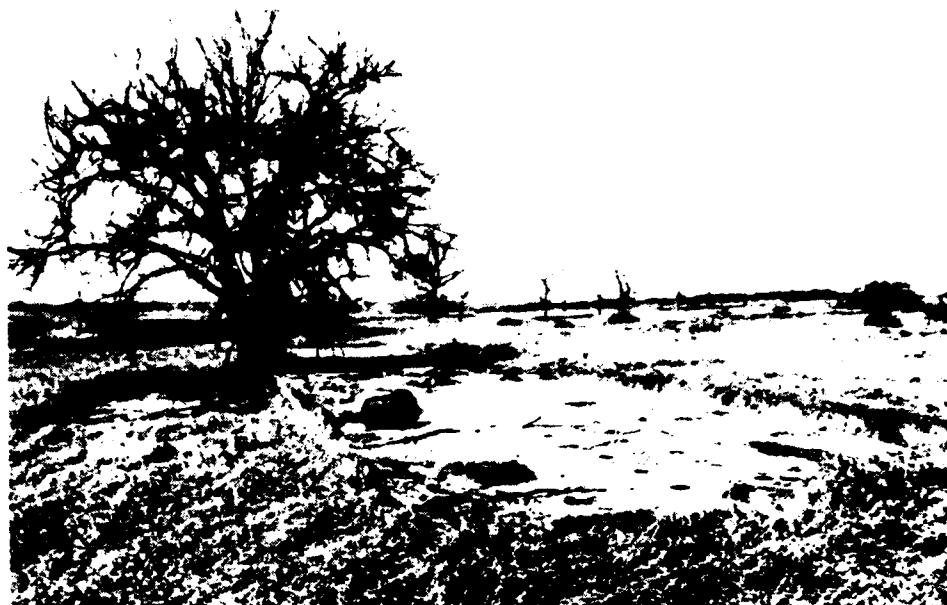
Figure 68. Feature 15: concrete foundation slabs and low walls (bathhouse and latrine remains?), view to the west.

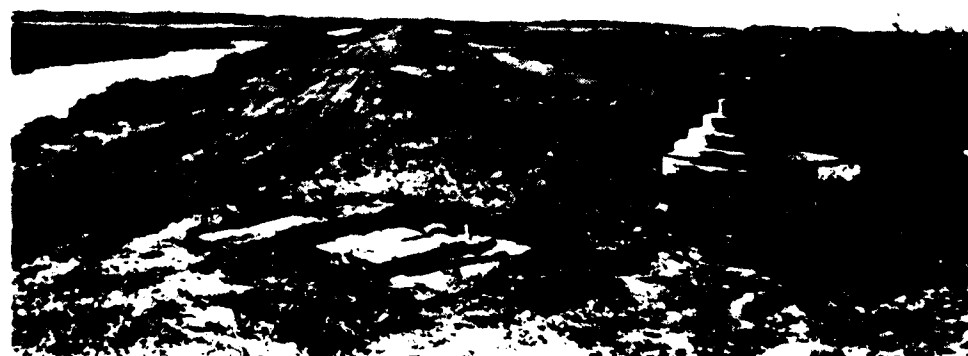
Figure 69. Feature 16: concrete slab foundation (center foreground), Feature 17: circular concrete fountain (far right), and Dam 332 embankment (center); view to the south.

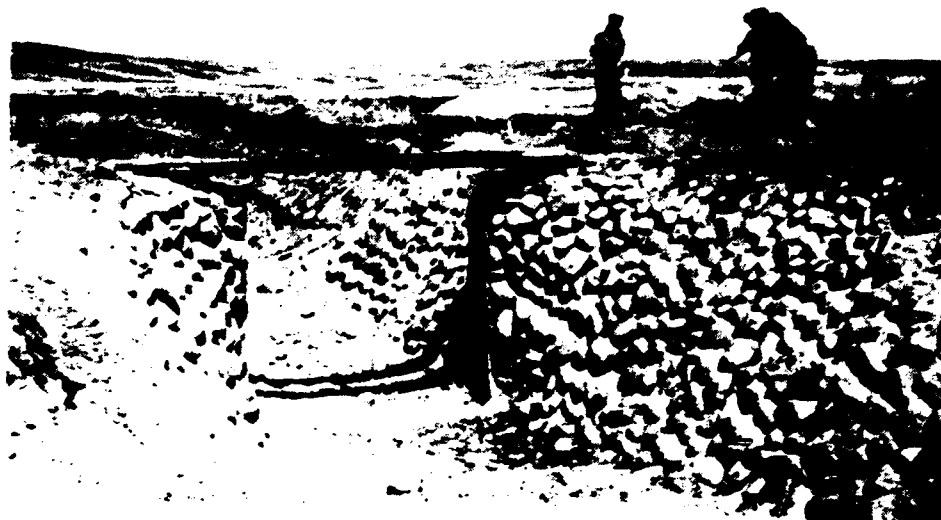
Figure 70. Historic view (1936) showing diversion channel and stop log structure built by the CCC between Ponds A and B at the Upper Souris Refuge.
